# Epitaph of a Cracking Hardband

“All cracked up.... & Buried in the Mud”

**It is time for the drilling industry to say goodbye to cracking and spalling hardbanding materials.**

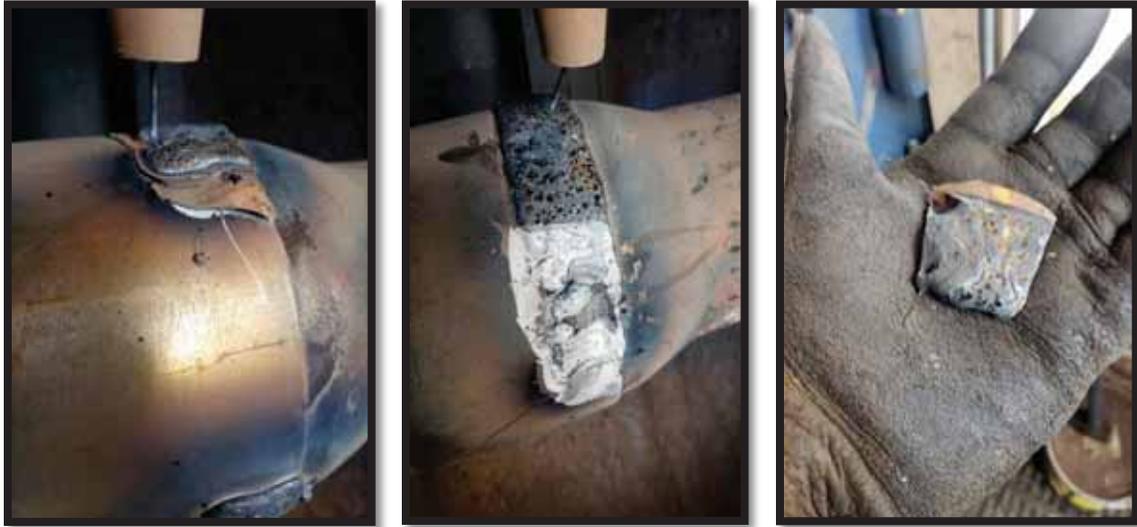
As shown in the above photos, the “delamination” of the current hardband verifies that the previous hardband is not a “true” non-cracking hardband alloy. The most likely cause is an unbalanced, unstable chemistry that begins to show its true properties after 2 or 3 re-applications.

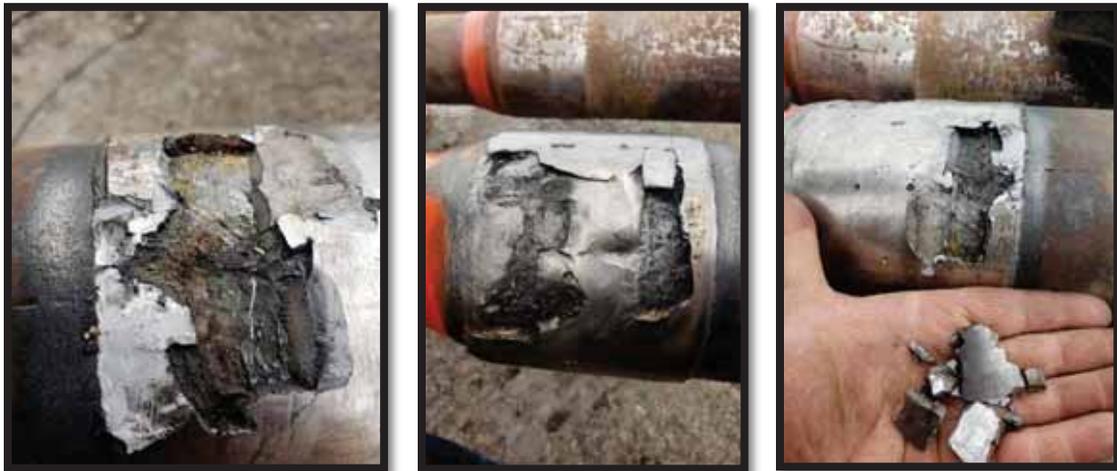
Upon further investigation, the below pictures show that the delamination is not limited to the current hardband application. The delamination is presenting itself all the way down to the parent material of the heavy weight tool joint and potentially into the tool material itself.

As the delaminated (or spalled) fragments of hardband have to go someplace, they are captured in the drilling mud and screens, and brought to the surface. The problem is that depending on the size of these pieces of hardband alloy, there are multiple issues that can arise as this debris works its way to the surface. These fragments have a hardness of ~60RC, if they get stuck in between the tube/TJ and the casing, they can put gouges into either and cause major damage. The spalled hardband can also cause major damage specific components to the BOP, etc. Fishing for loose pieces of hardband is expensive and time consuming.

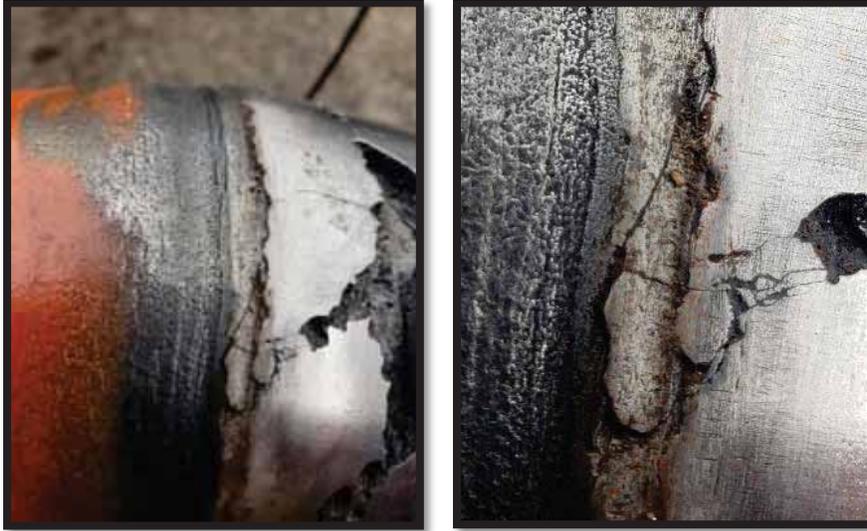
The below pictures show that the cracking of the hardband goes below the first pass of the original hardband, when it was applied to the heavyweight pipe.

Not only can the delamination (spalling) develop between the second and third layer, BUT the migration of the cracks can propagate into the initial layer of Hardbanding wire, and potentially into the tool joint. When delamination (spalling) happens, the stated “casing friendly” hardband now acts like a milling tool, due to the sharp edges of the delaminated fragments of hard material.

In addition, the spalling pieces of hardband will most likely get caught in the screens or they will have to be fished out.

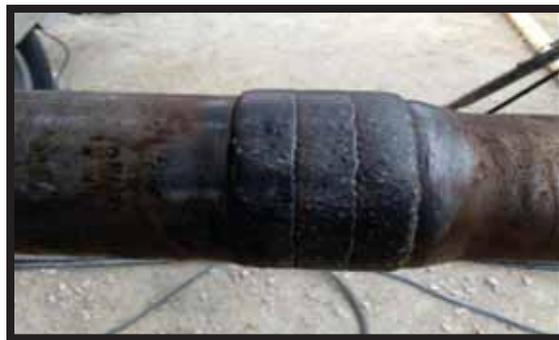
Duraband after multiple applications
