HARNESSING HARDBANDING APPLICATIONS

BOB MILLER, POSTLE INDUSTRIES, EVALUATES WHETHER HARDBANDING PRACTICES CAN SAVE PIPE OWNERS MONEY.

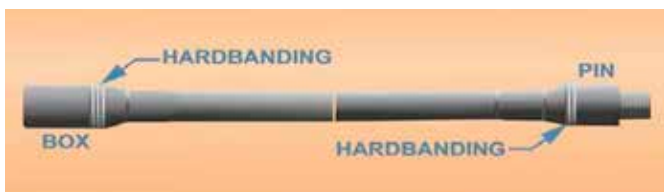
Figure 1. Drill pipe components.

Before dissecting the economics of hardbanding, a short review of drill pipe components is probably in order. A single drill pipe is made up of three major components: 1) tube, 2) box tool joint, 3) pin tool joint (Figure 1).

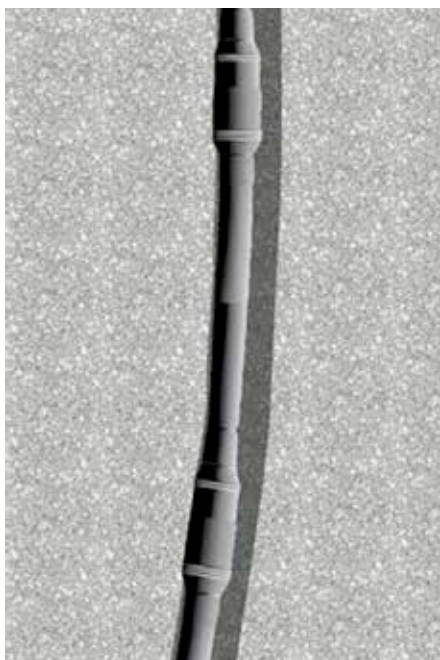
Figure 2. Wear on tool joint in a deviated hole.

Because the tool joint is required to maintain the same forged inside diameters as the tube, and provide for a threaded connection, an expansion of the tool joint OD is necessary. This expansion causes a bulge at either end of the drill pipe which subjects the tool joint to accelerated wear during drilling operations (Figure 2). Deviated holes cause considerably more wear than straight holes. To protect the tool joints from excessive wear, they are frequently hardfaced with a wear resistant welding alloy known as a hardband. These weld deposits are typically three 1 in. bands on the box and two 1 in. bands on the pin. The alloys used are designed to not only protect the tool joint, but are also designed to protect the casing from excessive wear. The hardbanding products are sometimes referred to as 'designer alloys' because each is specifically designed for the oilfield application. Two such products manufactured by Postle Industries, Inc. are Tuffband® NC and Duraband® NC (Figure 3), the latter being the premium alloy.

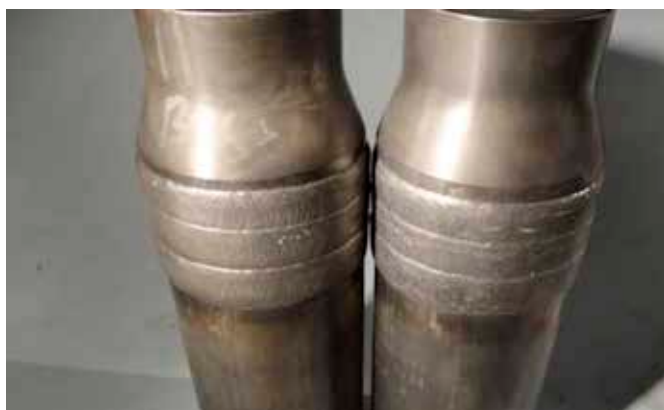
Figure 3. Tuffband (left) and Duraband (right).

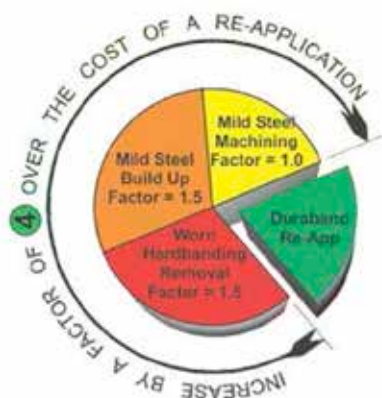
Figure 4. A pie chart illustrating the added costs incurred when hardbanding requires removal.

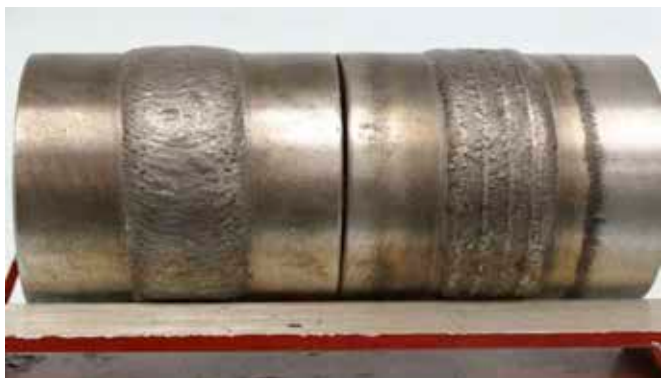
Figure 5. Comparison of conventional hardband to Coolband.

welding arc to a minimum and keeping the inside diameter of the tool joint below 400 °F (204 °C), the temperature at which common IPC materials start to deteriorate. This is accomplished by changing the welding DC polarity from electrode positive to electrode negative together with applying the hardbands with absolutely no oscillation.

These two parameters ensure that the heat affected zone (HAZ) does not encroach into the base metal and keeps the base metal HAZ hardness to less than 40 Rc, an accepted value imposed by some third party inspectors. Figure 5 compares conventional hardbanding and Coolbanding. Duraband is one of the few hardbanding wires that performs without undue spatter and a defect free weld deposit when the electrode is negative. Some hardbanding facilities apply water or a spray in addition to the Coolbanding procedure to ensure IPC integrity. It can be applied easily to either the pin or box tool joint. Applicators and welding operators require a special certification to conduct Coolbanding procedures.

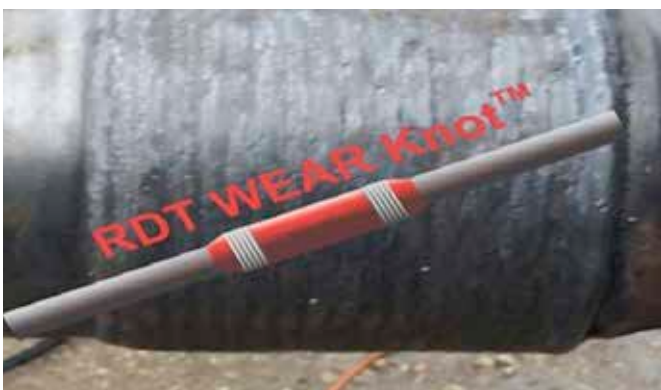
Figure 6. RDT wear knot with Coolbanding.

Some formations, coupled with deviated or horizontal directional wells, wear out the pipe bodies themselves. To combat this, RDT-USA has developed a drill pipe called a Wear Knot™. Figure 6 illustrates this configuration.

Because of the thinner walls compared to tool joints, the IPC is particularly vulnerable to burning during conventional hardbanding. Without hardbanding, the Wear Knot would wear quickly. But by employing Duraband in a conventional procedure on the initial hardbanding followed by Coolbanding on re-applications, the IPC is not burned and field deployment is quickly realised.
