HARDBANDING RE-APPLICATION COSTS

Hardbanding Costs are Dramatically Reduced with Tuffband[®] NC and Duraband[®] NC

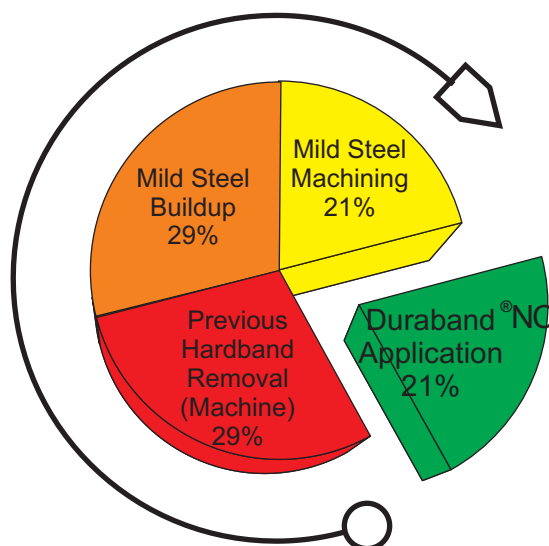
The cost of hardband re-application can be very expensive if the previous hardband must be removed before re-application can precede. As the chart below shows - close to 80% of the total cost of the re-application is dominated by previous hardbanding removal, the application of mild steel as a buildup, and subsequent machining of the mild steel to prepare the tool joint for the application of the hardband.

The Relative Cost of Worn Hardbanding Removal & Application of Duraband[®] NC or Tuffband[®] NC

Duraband[®] NC or Tuffband[®] NC can substantially reduce the cost of re-application since they can be applied over some previous hardbandings, without the need for removal, providing that proper inspection procedures have been carried out. However, there are certain ones that they cannot go over. If this is the case, then a complete re-application is required, which includes previous hardband removal, mild steel build up and machining. It should be noted that once this procedure has been completed, any subsequent reapplication of Duraband[®] NC or Tuffband[®] NC should not include removal of the hardbanding and any associated procedures.
